Contract #: 04-0120F4Cty: SF/ALA Rte: 80 PM: 13.2/13.9File #: 69.28**WELDING INSPECTION REPORT****Resident Engineer:** Pursell, Gary**Address:** 333 Burma Road**City:** Oakland, CA 94607**Report No:** WIR-004032**Date Inspected:** 03-Sep-2008**Project Name:** SAS Superstructure**OSM Arrival Time:** 1400**Prime Contractor:** American Bridge/Fluor Enterprises, a JV**OSM Departure Time:** 2300**Contractor:** Zhenhua Port Machinery Company, Ltd (ZPMC), Changxing Island **Location:** Shanghai China**CWI Name:** Chen Xi**CWI Present:** Yes No**Inspected CWI report:** Yes No N/A**Rod Oven in Use:** Yes No N/A**Electrode to specification:** Yes No N/A**Weld Procedures Followed:** Yes No N/A**Qualified Welders:** Yes No N/A**Verified Joint Fit-up:** Yes No N/A**Approved Drawings:** Yes No N/A**Approved WPS:** Yes No N/A**Delayed / Cancelled:** Yes No N/A**Bridge No:** 34-0006**Component:** OBG**Summary of Items Observed:**

Tower Shop Bay 3 Deck Panel repairs

89m Mock-up Submittal SUB101R2

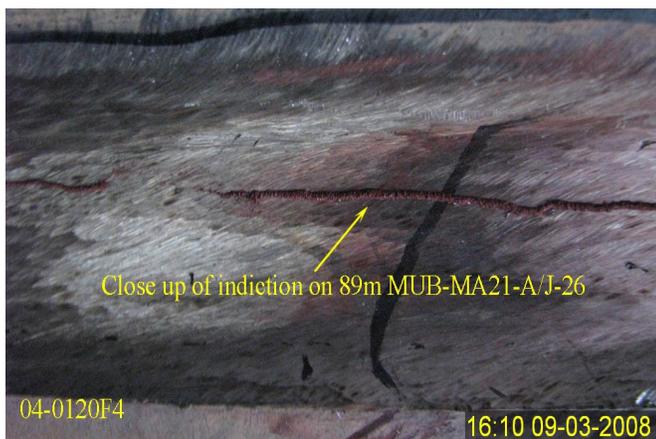
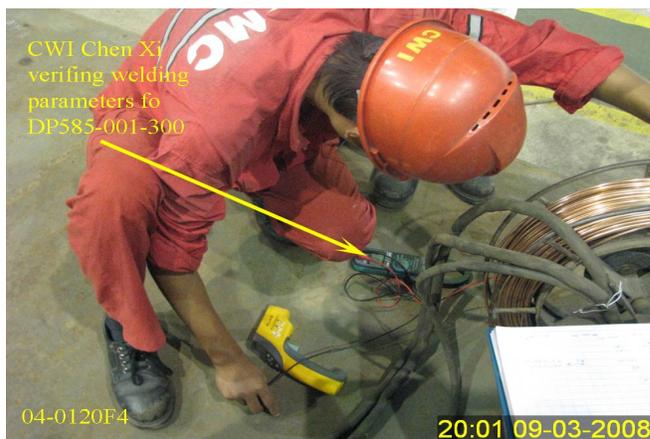
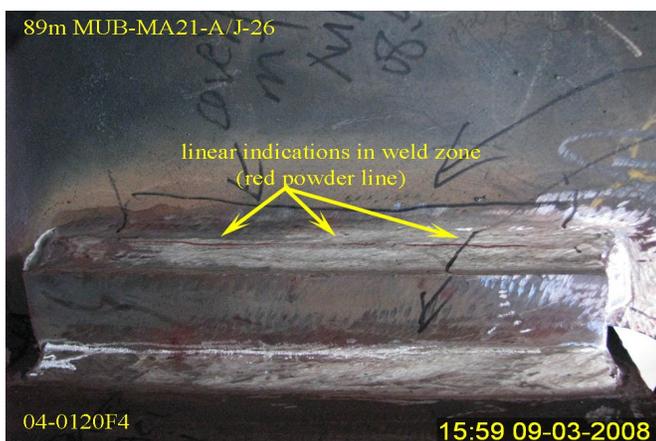
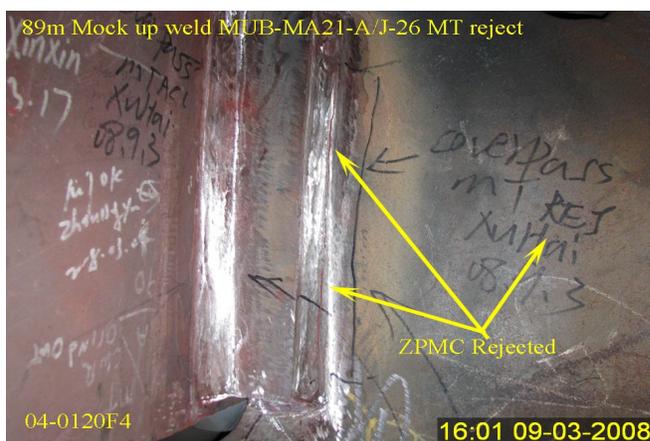
This QA inspector was informed by SMR Josh Ishibashi that ZPMC had completed the welding of lug plate to diaphragm and would be performing the MT of weld MUB-MA21-A/J-26 for the 24 hour hold point inspection as outlined in the approved procedure. Upon completion of the MT ZPMC had discovered a 250mm rejectable linear indication within the weldment. No further work was observed at this location by this QA inspector for this date on the 89m mock-up. Below are digital photos of the indication as outlined above.
